WORLD PIPELINES

United Pipeline Systems explains how the application of an HDPE liner helped to solve a persistent internal corrosion problem on a crude oil pipeline.

Figure 1. Tite Liner® installation.

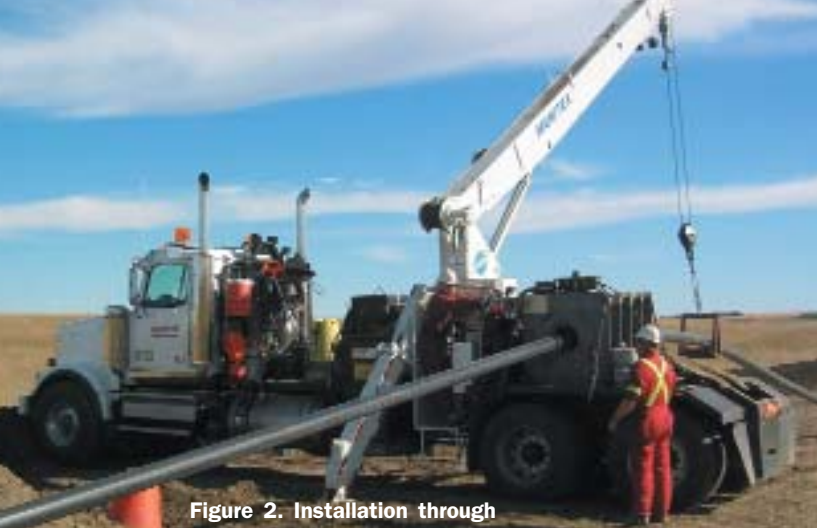
Figure 2. Installation through roller reduction box.

The Tite Liner® system utilises an HDPE liner that is inserted into carbon steel pipelines. The liner is custom extruded to be slightly larger than the inside diameter of the steel pipe. The process relies on a roller reduction box to reduce the liner to a diameter smaller than that of the inside of the steel pipe. United then uses a winch truck (wireline unit) to pull the liner through the roller reduction box and into the pipe itself. The elastic nature of the material causes it to expand tight against the pipe. Long pipeline projects, such as this one, are divided into sections to be lined and then flanged on both ends. After the liner is installed, HDPE flanges are attached to the ends of the liner, covering the steel flanges, and the pipeline is then bolted together. Once all the sections are combined, the resulting pipeline has a continuous pipe/liner that will protect the steel pipeline from internal corrosion.

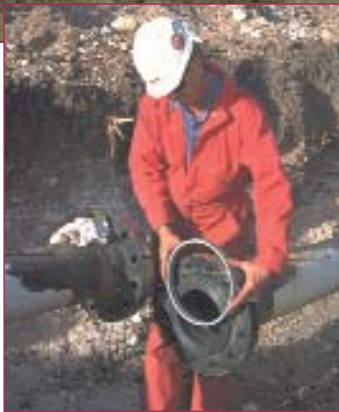
Figure 3. Steel spacer ring for flange connection.
