WORLD PIPELINES

Reprinted from April 2005

United Pipeline Systems explains how the application of an HDPE liner helped to solve a persistent internal corrosion problem on a crude oil pipeline.

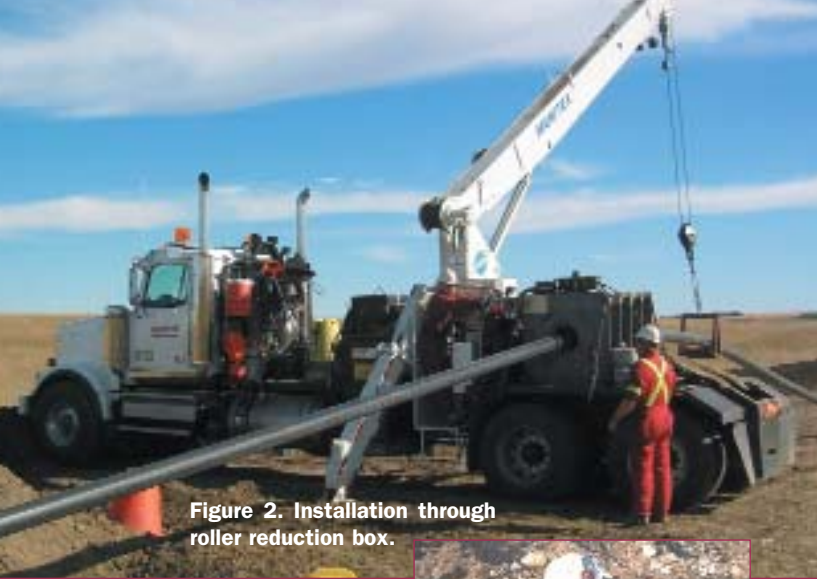
The Tite Liner® system utilises an HDPE liner that is inserted into carbon steel pipelines. The liner is custom extruded to be slightly larger than the inside diameter of the steel pipe. The process relies on a roller reduction box to reduce the liner to a diameter smaller than that of the inside of the steel pipe. United then uses a winch truck (wireline unit) to pull the liner through the roller reduction box and into the pipe itself. The elastic nature of the material causes it to expand tight against the pipe. Long pipeline projects, such as this one, are divided into sections to be lined and then flanged on both ends. After the liner is installed, HDPE flanges are attached to the ends of the liner, covering the steel flanges, and the pipeline is then bolted together. Once all the sections are combined, the resulting pipeline has a continuous pipe/liner that will protect the steel pipeline from internal corrosion.

Figure 2. Installation through roller reduction box.

Trucks were set up to transport the crude from one end of the pipeline to the other. The welding crew then cut and welded steel flanges into the pipeline, making way for the installation crew. The installation crew consisted of the wire-line unit on one end of the section to be lined and the roller reduction box on the other end. This crew would work its way down the pipeline, pulling section after section of liner into the pipeline. After the liner was installed, it was allowed to relax and grow tight overnight, permitting the flanging/bolt up crew to complete the Tite Liner® System. The flanging/bolt-up crew installed the HDPE flanges or stubends at each end, and the steel flanges were then bolted together. Next, the lined sections were air tested to verify the integrity of the liner. This process was repeated for each section until the pipeline was fully lined. The installation process averaged approximately 1.2 miles per day, with as much as two miles completed in a single day, resulting in minimal shutdown time. Upon completion of the lining, the cleanup crew followed and backfilled the excavations, mended fences and cleaned up the light impact on the right of way. With the lining complete, the pipeline was placed back in service for the transportation of crude oil.

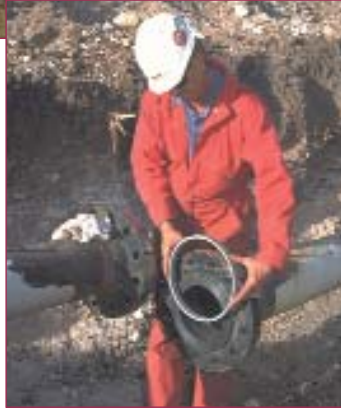
Figure 3. Steel spacer ring for flange connection.
